July 11, 2007

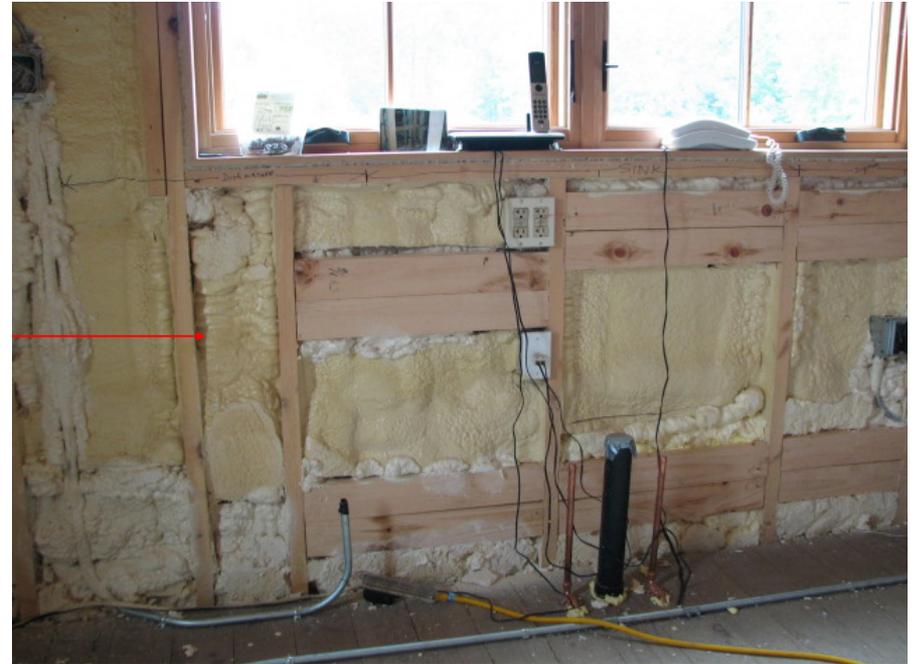
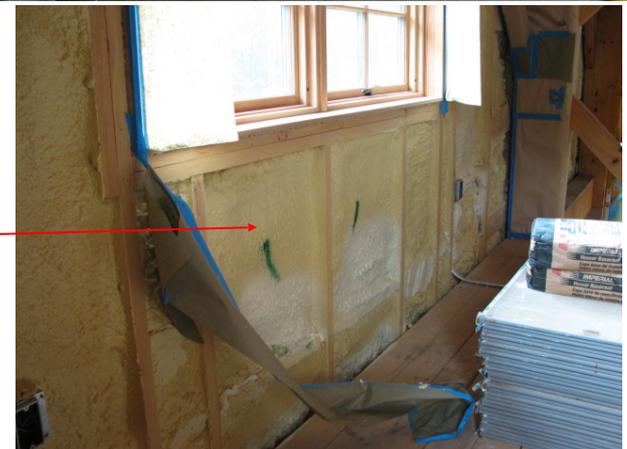
1.1 Air Barrier & Thermal Alignment

While variations in insulation thickness may impact overall effective R-value, the ES requirement is fulfilled:

“All spray foam acts as both an air barrier and a thermal barrier so it is not critical that the foam be aligned with the interior finish.” TBGp11

Much of the wall surface area has full insulation coverage.

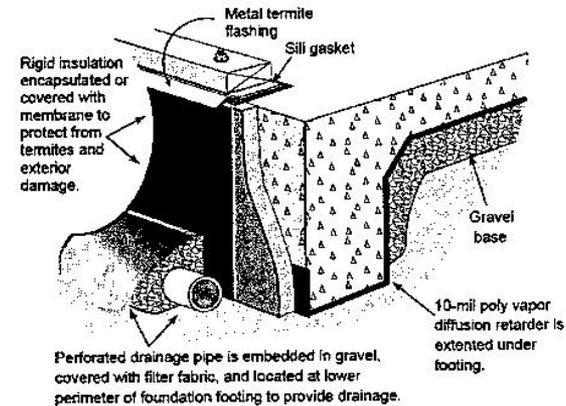
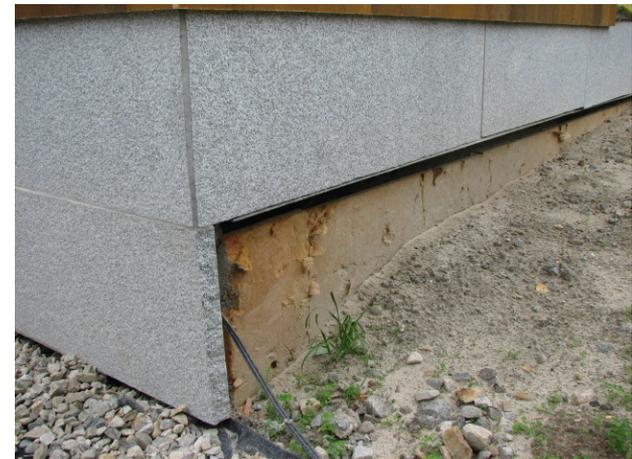
1.4 Slab Edge Insulation

Inspection of the foundation and drawings appear to be in compliance with complete slab edge insulation, however Builder Verification will be required on the checklist. Up to six items are allowed to be verified by builder.

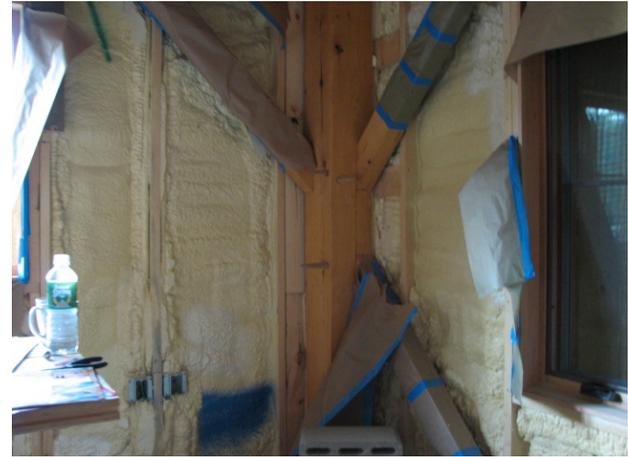
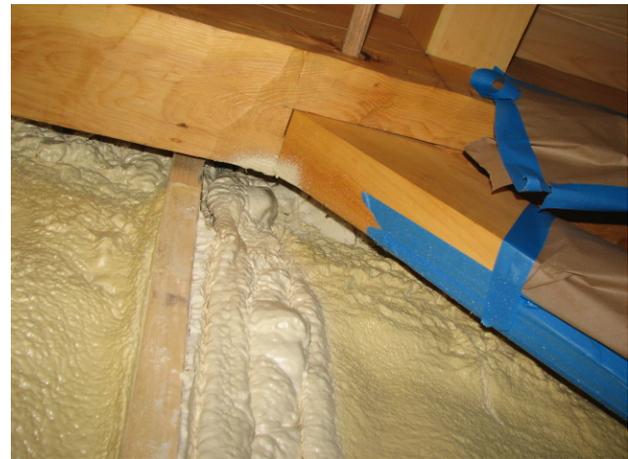
1.5 Air Barrier at all Band Joists

The curtain wall, insulated with closed cell spray foam, and surrounding the timber frame structure, successfully creates a continuous air barrier in direct contact with a thermal barrier. This is considered a best practice in the Energy Star's Thermal Bypass Checklist.

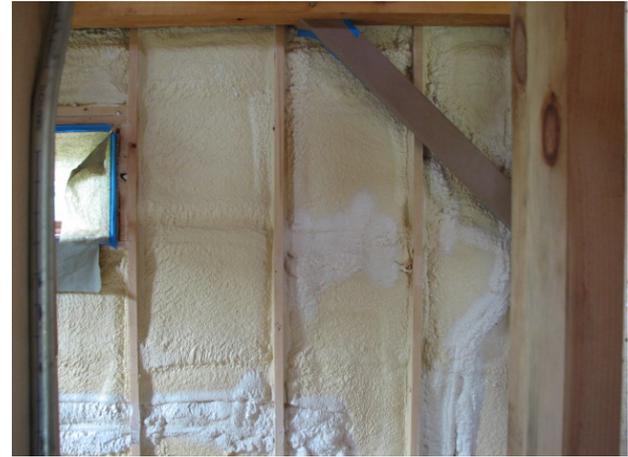
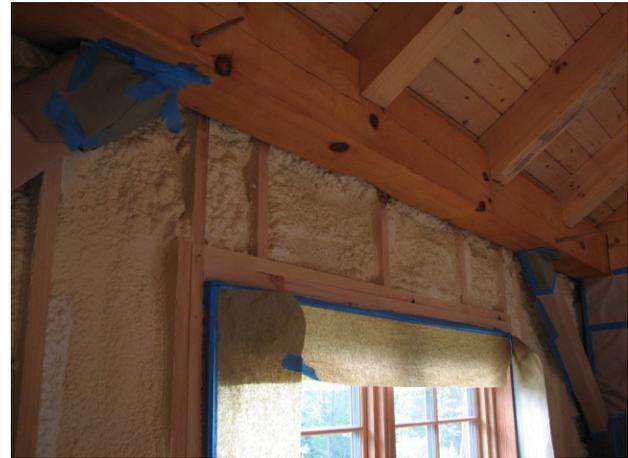
1.6 Minimize Thermal Bridging

Preventing thermal bridging at vertical studs is another recommended best practice but not a requirement for Energy Star Certification.

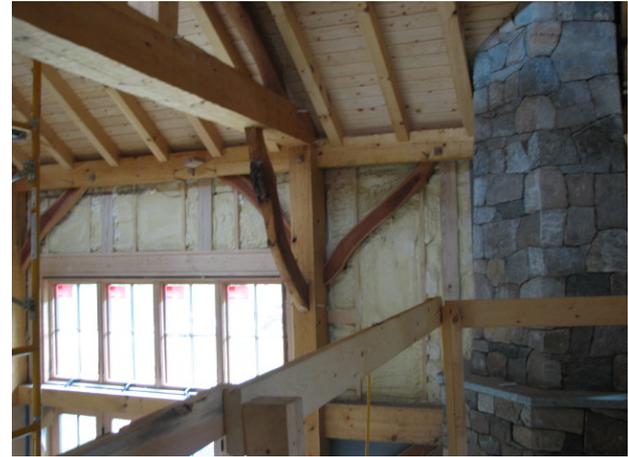
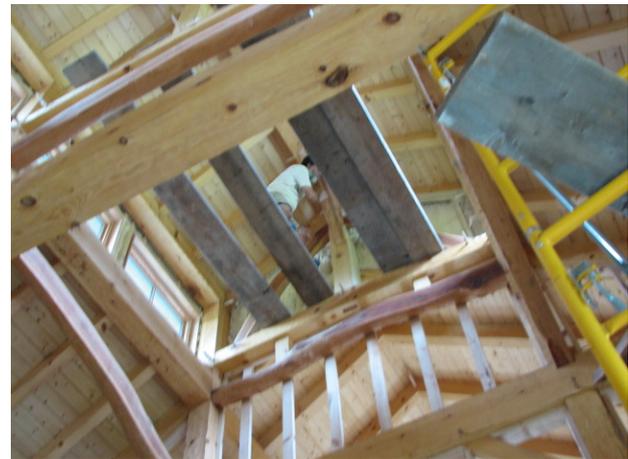
2. Walls Adjoining Exterior Walls or Unconditioned Spaces

The building design's of both an insulated curtain wall and lack of an attic and any knee walls greatly minimizes areas which commonly create areas of significant thermal bridging and air infiltration and therefore heat loss.

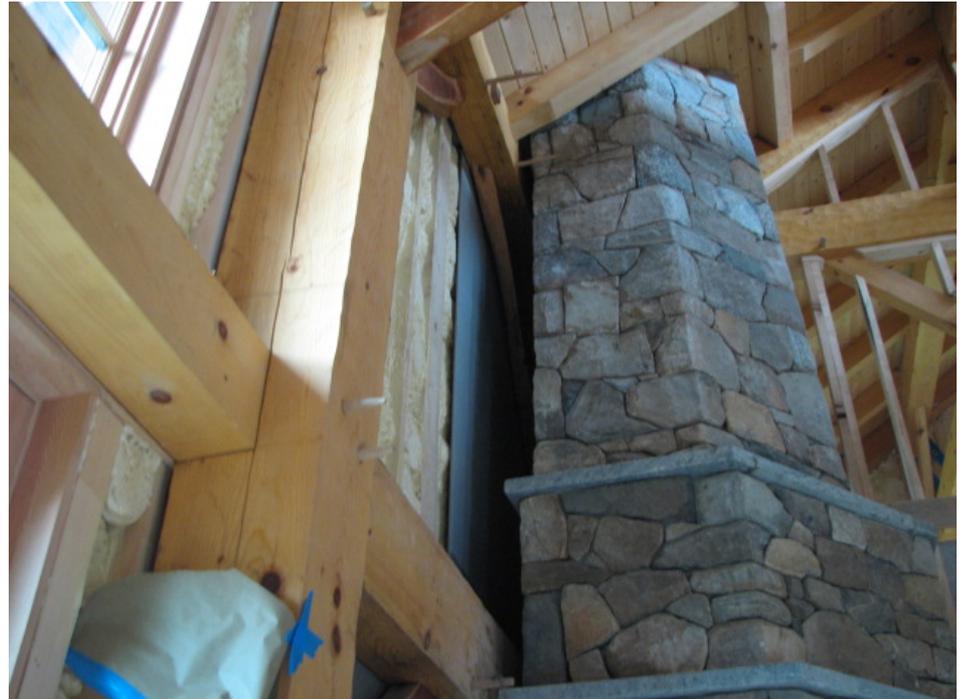
2.2 Wall behind Fireplace

While there is no reason to suggest non compliance, verifying continuous foam insulation (and air barrier) in the wall behind the fireplace will also require Builder Verification. The builder will also be asked to verify 2.3 'Insulated Attic slopes' (roof) – drawing details are in compliance with ES.

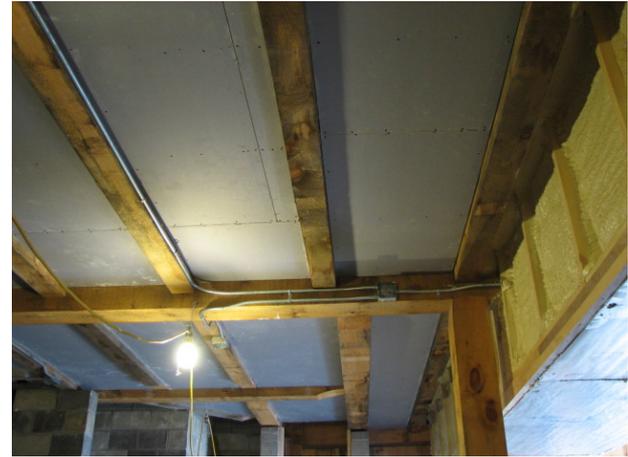
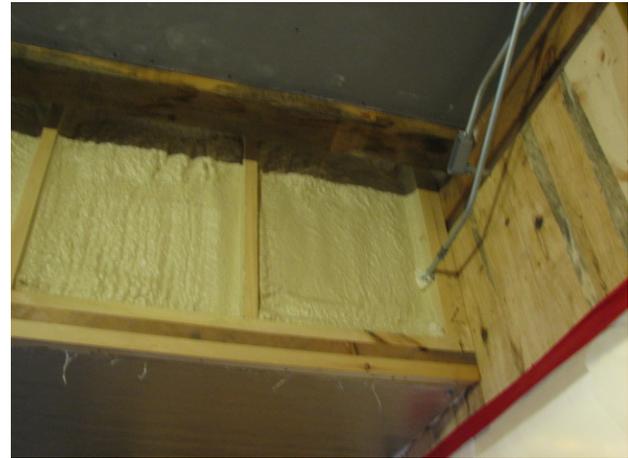
Again, the use of spray foam insulation creates an effective air barrier in garage walls and ceilings.

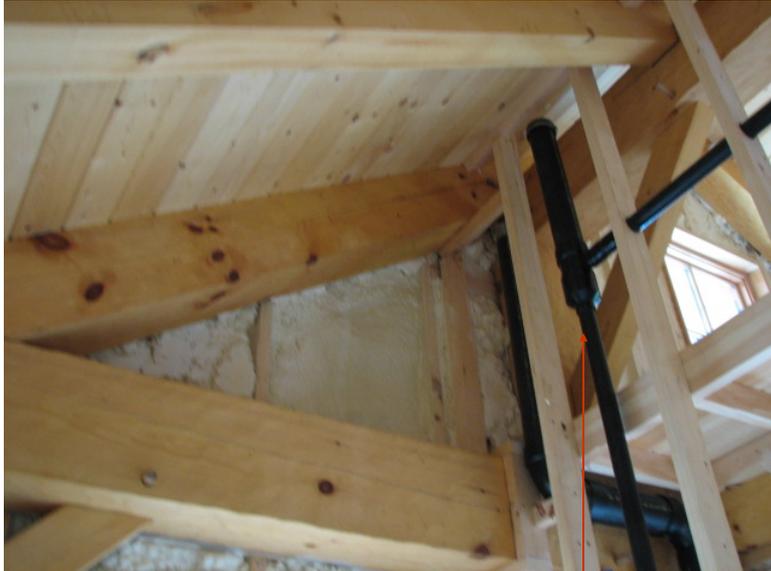
Piping in partition walls.

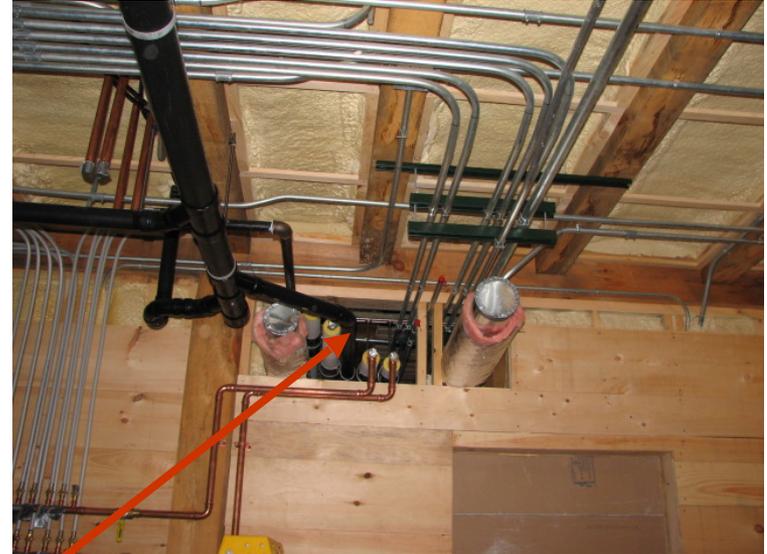
Considerable air leakage through this chase in mechanical room will need to be re-inspected after work is completed to make sure no connection to the garage remains.

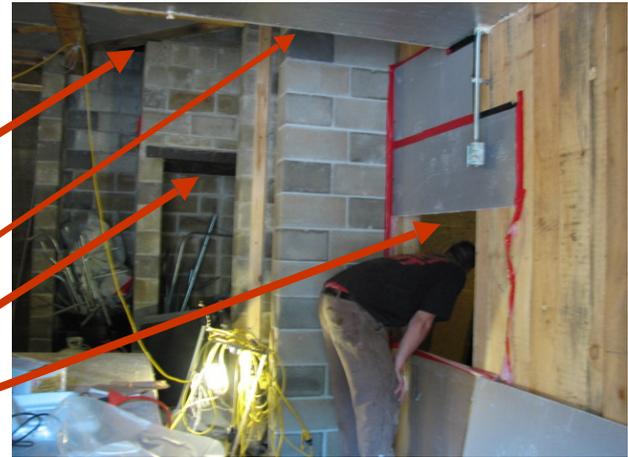
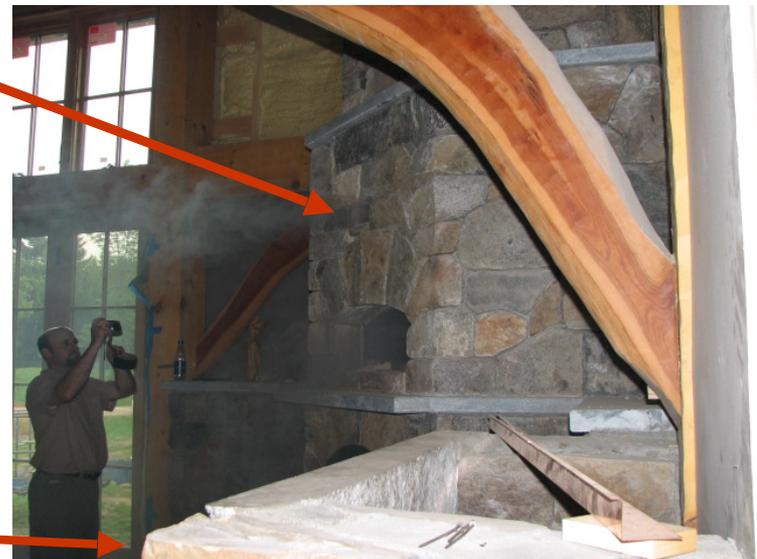
4. Shafts and Chases

Several areas relating to the chimney were airways between the garage and the living area. The insulation company was aware of these and working to eliminate as best as possible while I was there. Since there is other work to be completed, a final inspection of these areas is critical.

The crack between the chimney and floor also need to be completely sealed filled (not shown)

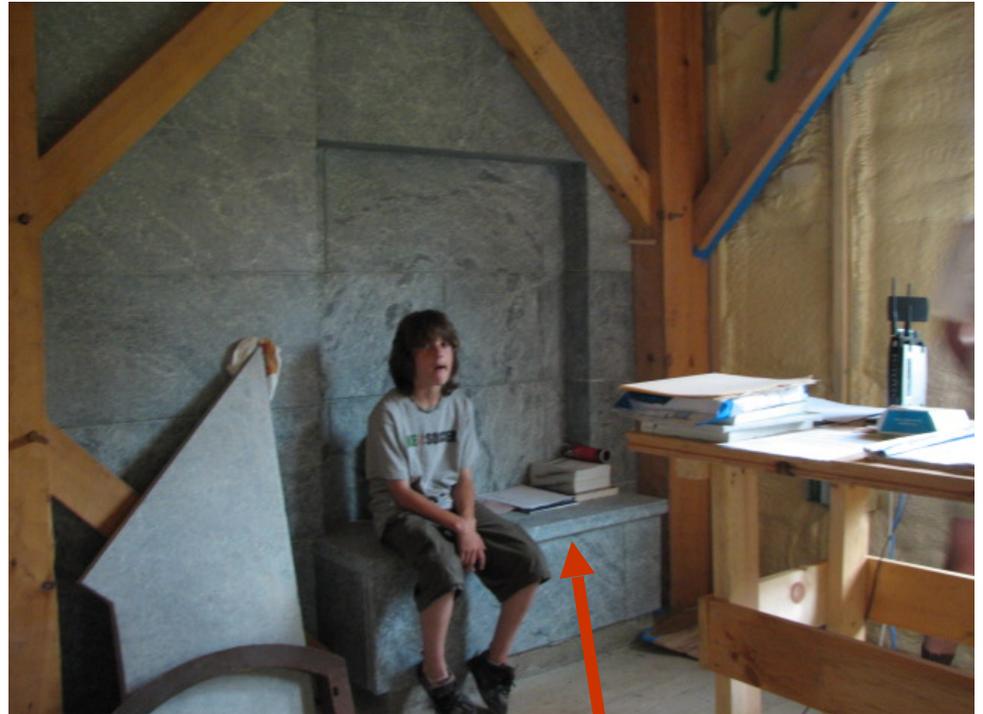
During blower door test, air leaked under lip of soap stone bench. A thorough joint sealing is recommended.

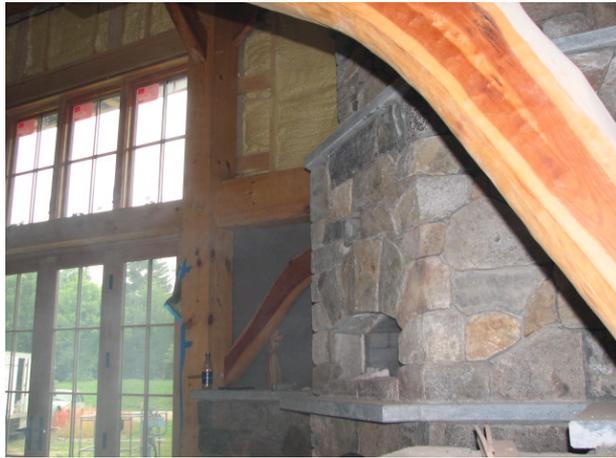
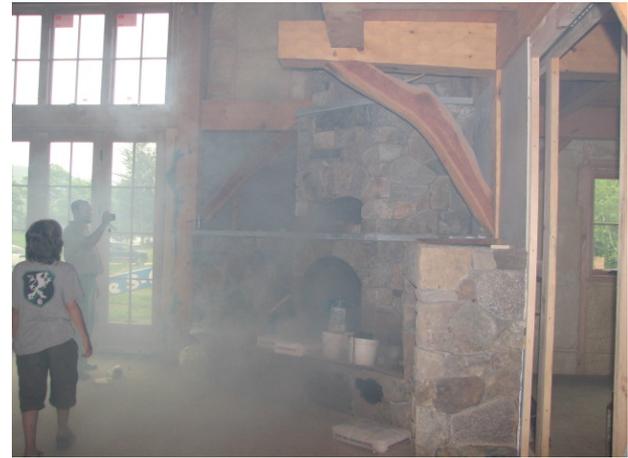
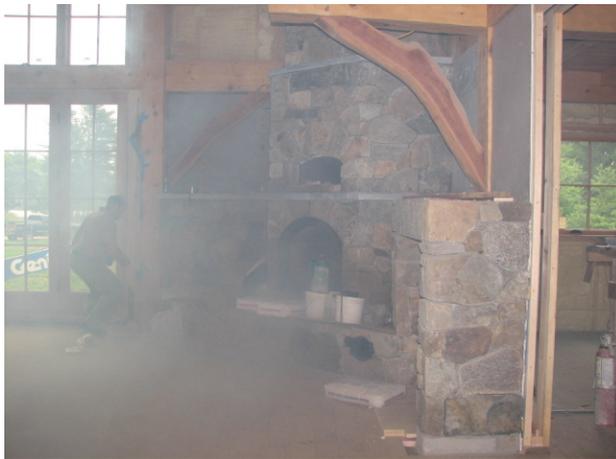
Connection between living area and garage

- The only areas of current concern are in the basement –the floor/ceiling and shaft/flue connections between conditioned basement and living areas and unconditioned garage space.
The garage/condition space connection is a major concern for both heat loss and indoor air quality.

With the house depressurized, fog was created in the garage and quickly filled the living area upstairs. Representatives from the testing company seem completely aware of the importance of severing this connection for thermal performance and air quality concerns!

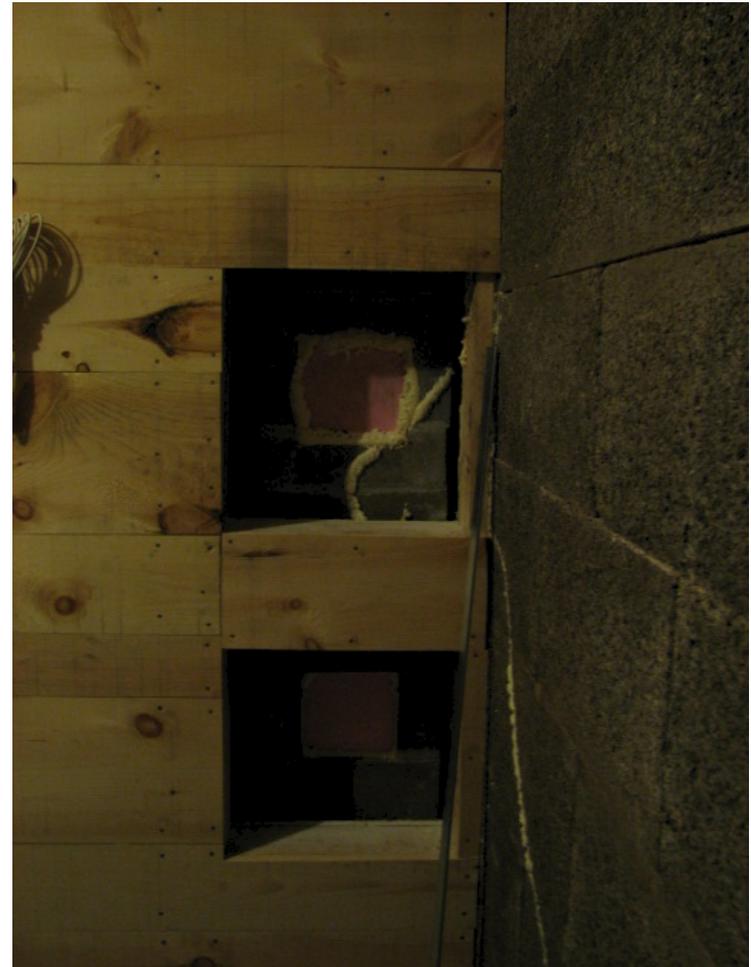
4.3 Flue Shaft

The final area of concern: It was impossible to detect exactly where air was coming from but there was a considerable amount of air leakage coming through this future flue area.
