July 11, 2007

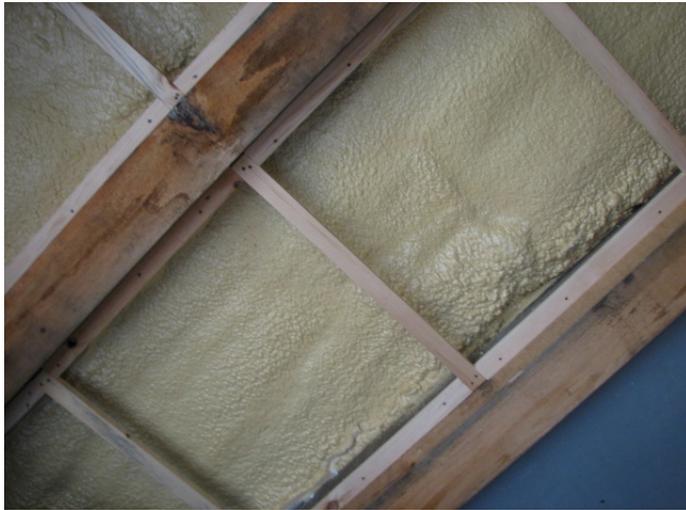
3. Floors Between Conditioned & Unconditioned Spaces

Again, the use of spray foam insulation creates an effective air barrier in garage walls and ceilings.
